**Request Concerning Use of Bathroom Heater/Dryers
and Notice of Inspections and Parts Replacement**

With respect to certain models of bathroom heater/dryers manufactured by Rinnai Corporation between June 2001 and January 2009, it has been discovered that, on rare occasions, it is possible that the equipment could experience burnout. For this reason, Rinnai has decided to carry out inspections and parts replacement free of charge.

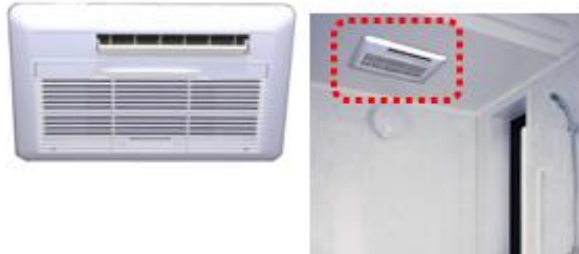
External view of equipment concerned

Because the circulating fan motor is positioned in the ventilation passage, water and the like may intrude into the equipment’s interior, which may cause burnout on extremely rare occasions. Therefore, in addition to checking the equipment’s operation, we will replace the parts with those that do not allow water intrusion, as a preventive measure. We estimate that the work will take around 3 hours.

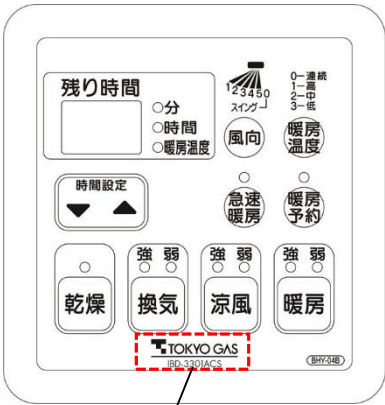
The Tokyo Gas brand remote control displays the model name (IBD –3301ACS) under the brand mark, so please confirm the “Model Name.”

<p>Brand mark, model name</p>
